# Manhole Inspection Summary

Manhole # S13Q\_\_023MH

**Inspection** ☐ Is Incomplete Rating: **4) Poor**

**Location** Address: **2833 Sunset dr**

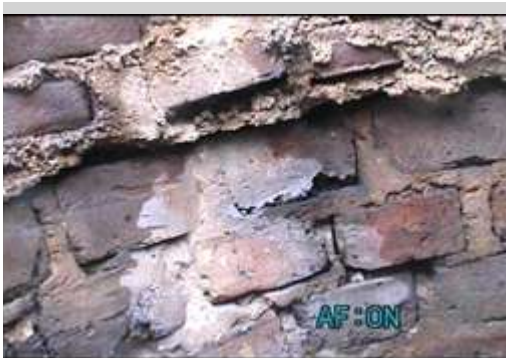
Defect 8

Condition: ☐ Sound ☐ Cracked ☐ Root Intrusion ☐ Loose Brick ☒ **Deteriorated**

chimney area deteriorated

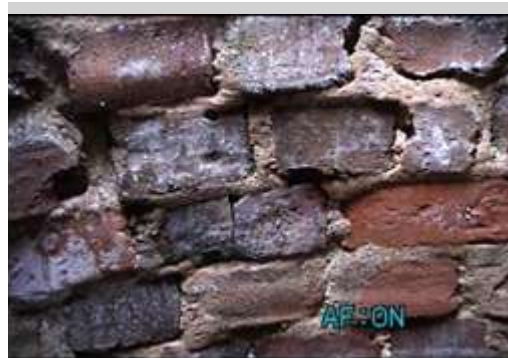
Defect 7

Condition: ☐ Sound ☐ Cracked ☐ Root Intrusion ☐ Loose Brick ☒ **Deteriorated**

cracked bricks and deteriorated corbel area

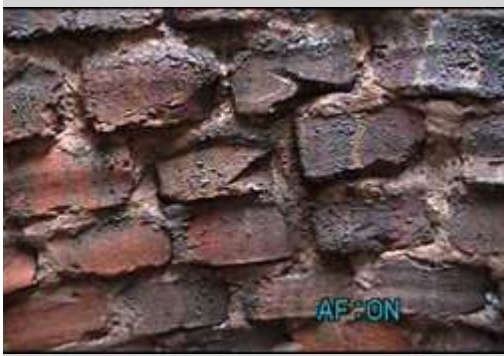
Defect 6

Condition: ☐ Sound ☐ Cracked ☐ Root Intrusion ☐ Loose Brick ☒ **Deteriorated**

deteriorated barrel area

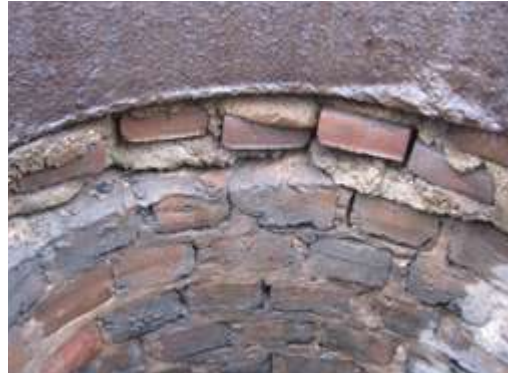
Defect 4

missing mortar

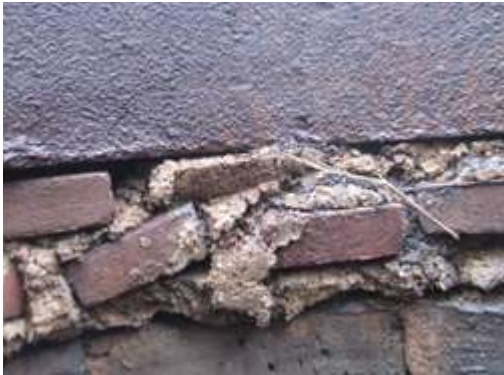
Defect 3

Infiltration: ☐ None ☒ **Joint** ☐ Cracks ☒ **Mortar** ☐ Roots ☒ **Wall**

infiltration from joint chimney frame as well as from gaps in mortar around bricks

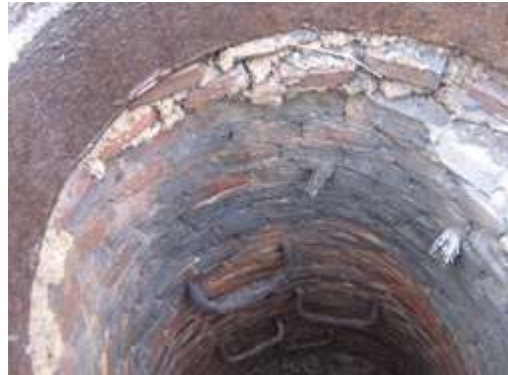
Defect 2

deteriorated wall as well as missing mortar in spots

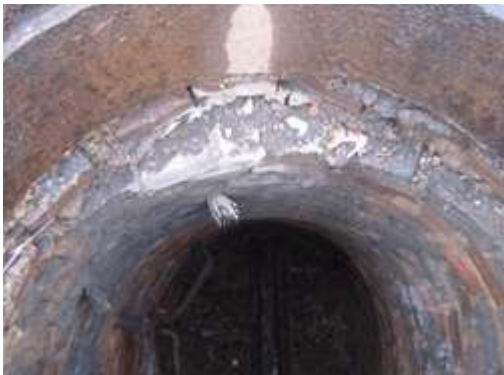
Defect 1

**Steps** Count: **5** Missing: **1** ☒ **Corroded**

lid/frame infiltration, as well as missing one wrong other are corroded

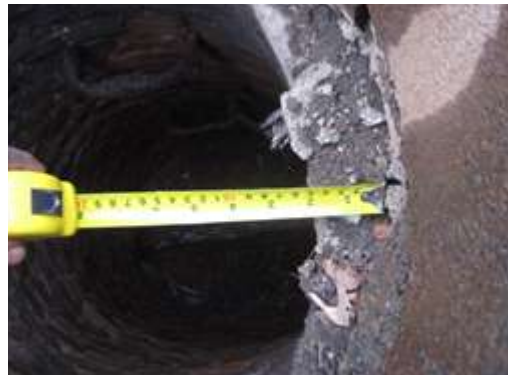
Defect

**Frame** Offset: **2** (in.) Condition: ☐ Sound ☐ Cracked ☒ **Leaks**

offset 2 inches
